Large Scale Testing of Drystone Retaining Structures

for the degree of Doctor of Philosophy

Department of Architecture and Civil Engineering

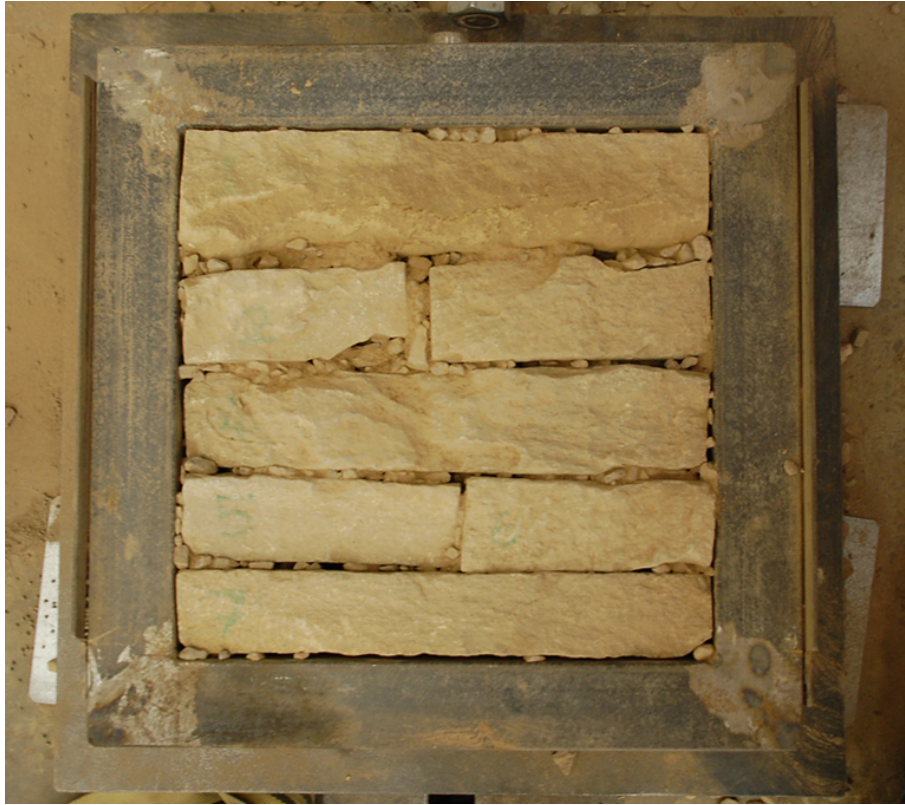
Four different normal stresses were applied, with each being tested six times to ensure an adequate amount of data was obtained. The friction angle was measured to be 45.9° (fig 3-10). It is to be expected that there was a relatively large scatter of the results given the relatively unpredictable nature of the aggregate and its interaction with the wall, however sufficient data is present to justify some confi-

Figure 3-9: Recreation of stone coursing within the shearbox apparatus

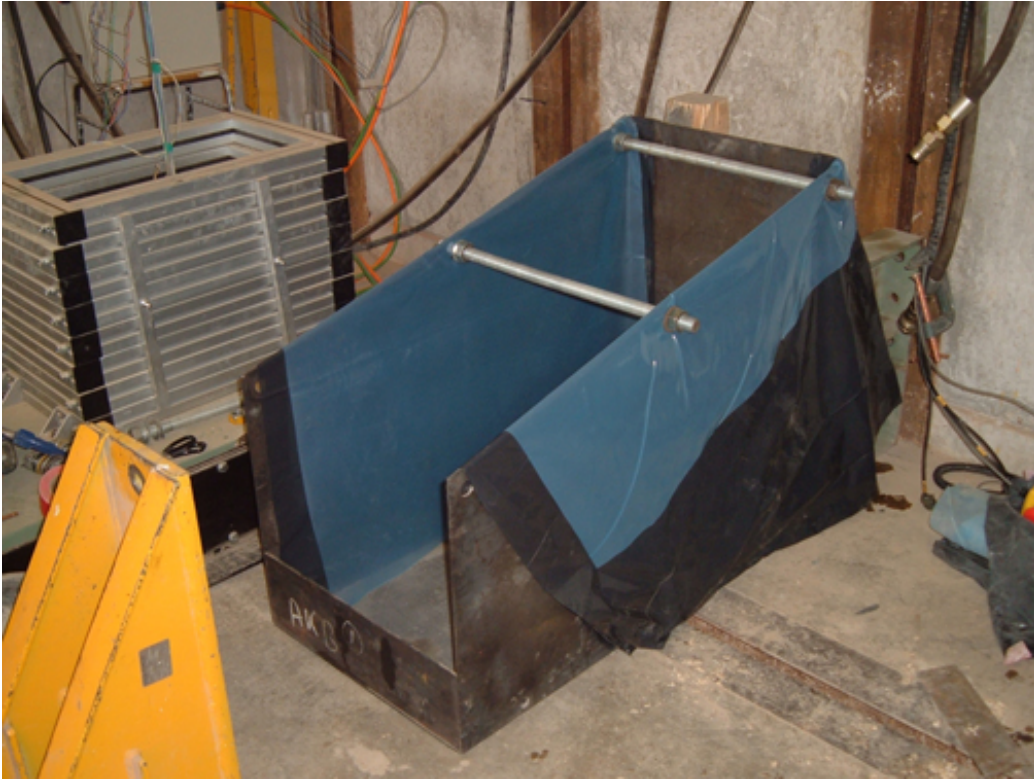
To house the tests, a steel box was constructed, with the capacity to hold scale walls 500mm in height and 500mm in width. The box was lined with a double layer of plastic sheeting, to help reduce friction at the edges and hence minimise end effects (fig. 3-11). Concrete or timber blocks of varying geometries were tested to recreate the wall material, with pellets of lead shot (2mm-3mm diameter) used as the backfill material.

Figure 3-11: small-scale testing rig

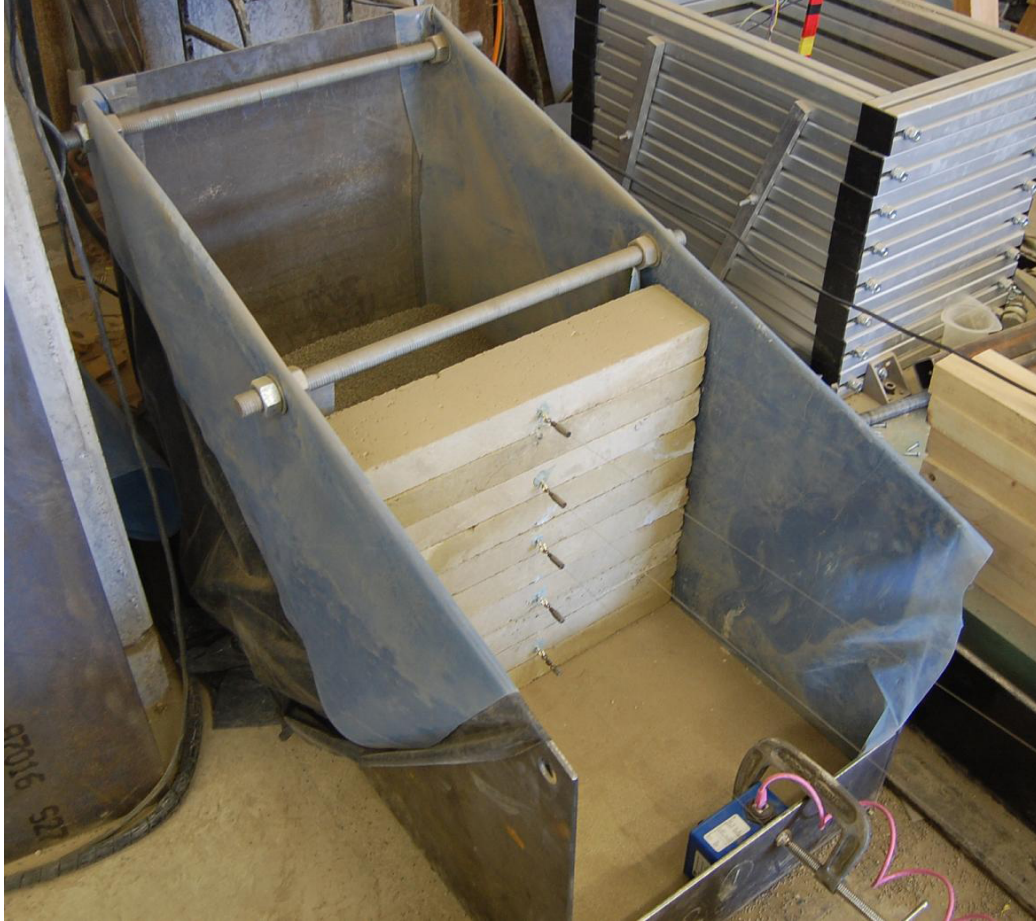
hence the active pressure applied - was known at all times. The backfill height was slowly raised until failure occurred, proceeding slowly to allow for any movements and the recording of the wall position.

Figure 3-12: small-scale testing procedure

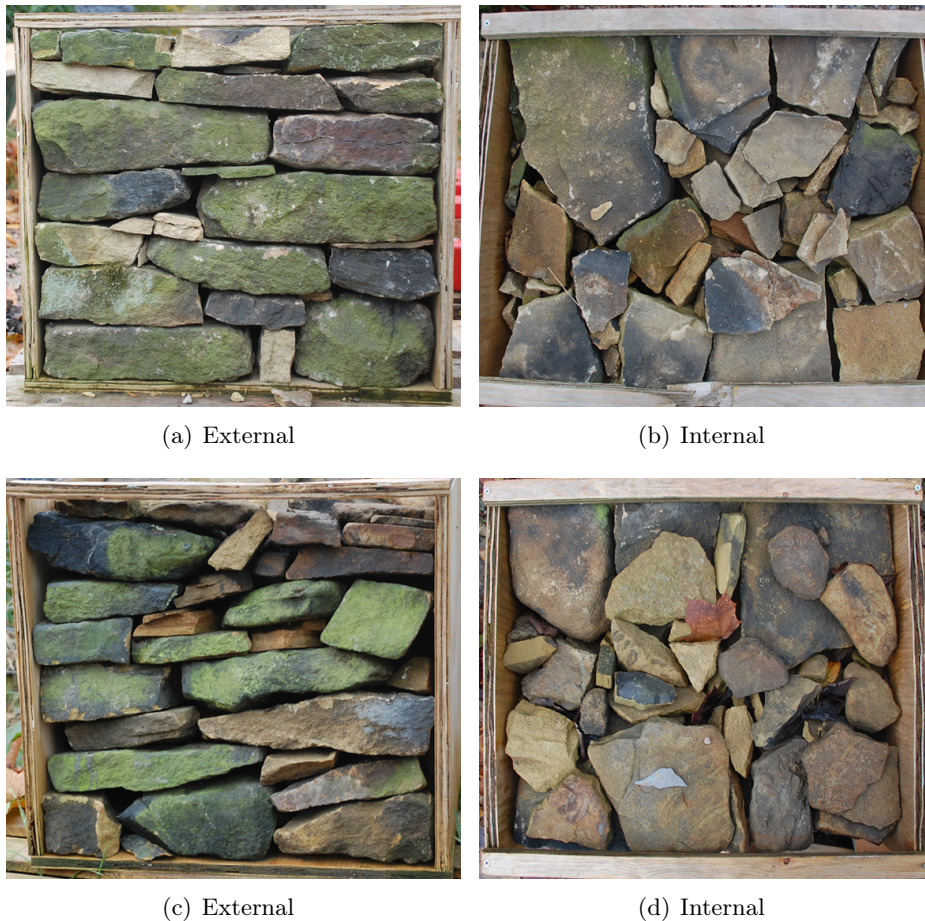
In an attempt to correlate the external appearance of a wall with the internal voidage, the limestone samples were analysed using an adapted program originally designed to produce stereo photogrammetric images from pairs of photos, written by Paul McCombie. This program allowed individual photos to be assessed, giving a ratio of the black to white spaces in the image. Each photo of the sample box

Figure 3-18: Void testing: Yorkshire stone (a & b: best practice; c & d: poor construction)

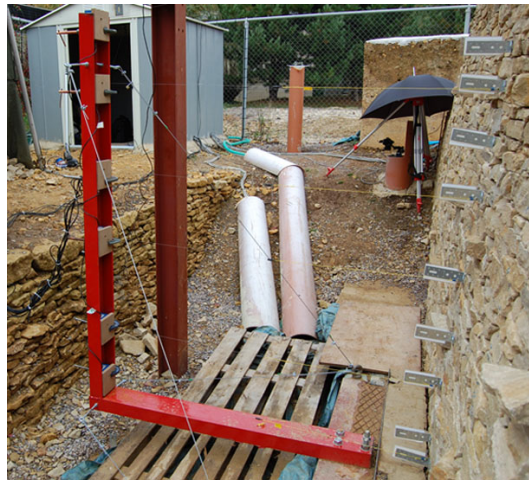
(a)

To mount the transducers, an L-shaped steel arm was attached to the platform and cable-tensioned to eliminate movement (fig. 5-17(a)). By attaching the arm to the platform, this ensured that the transducers recorded movements of the wall relative to the platform. In this way, any movements or rotations of the platform are automatically accounted for, with the draw wires giving only the wall displacements. The draw wire cables were susceptible to slight movements due to wind, vibrations etc., however, the effect of these was negligible.

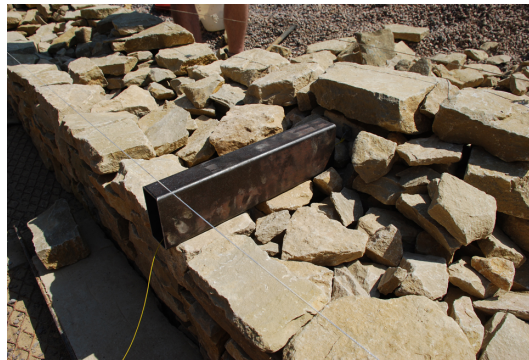
(a)

Walls 3, 4 and 5 also incorporated draw wires to monitor the internal face of the walls. To achieve this, 100mm x 50mm rectangular hollow sections replaced selected face stones, allowing access to the internal face. The draw wires were then attached to the internal face block and the cable passed through the channel section and out of the face of the wall. It was ensured that the steel channel section was not in contact with internal face block, allowing sufficient space for the internal block to move freely (fig. 5-18).

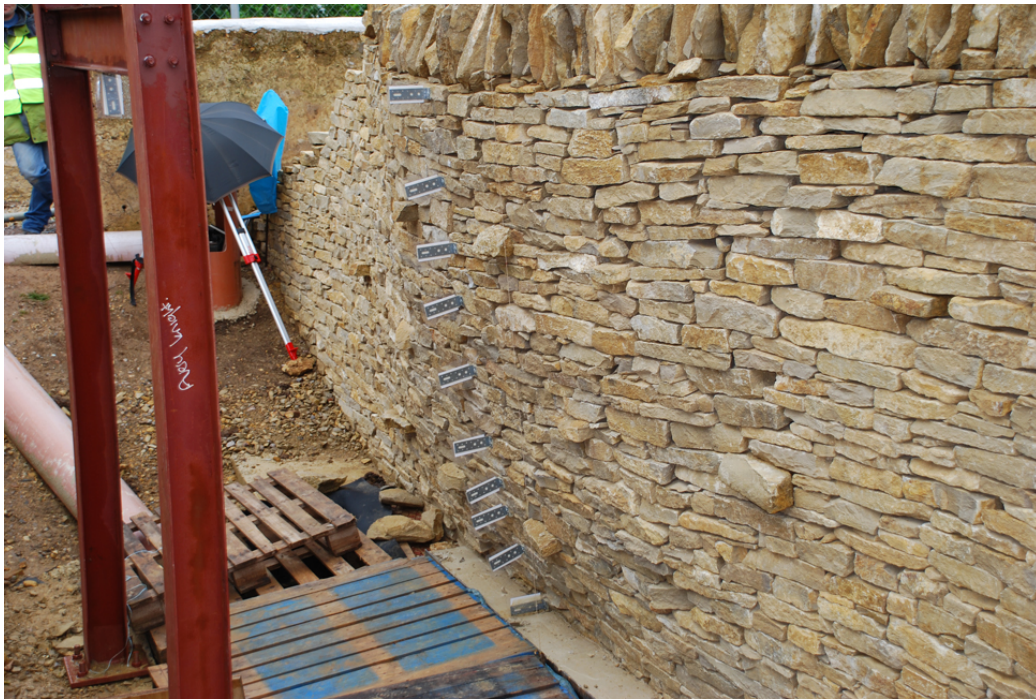
The fifth day was again a combination of platform rotation and surcharging. Initially, the front jacks were lowered a further 25mm, causing a rotation of 1.02° . At this point the jacks were stopped, and not moved again until failure.

Figure 6-7: Wall 1: Prior to failure

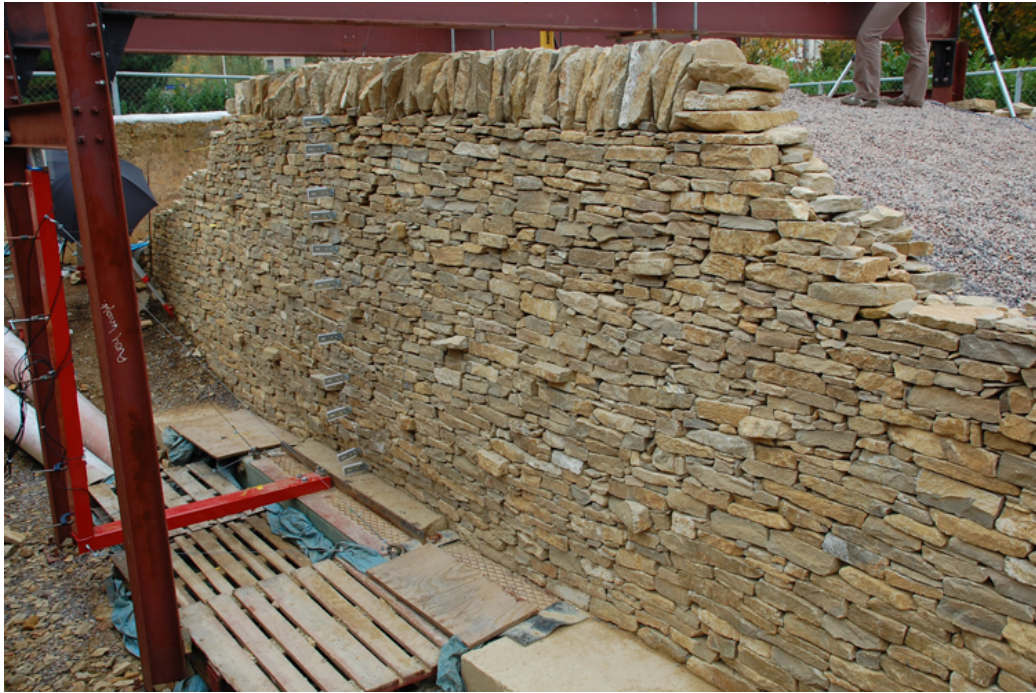
Figure 6-14: Wall 2: Prior to failure

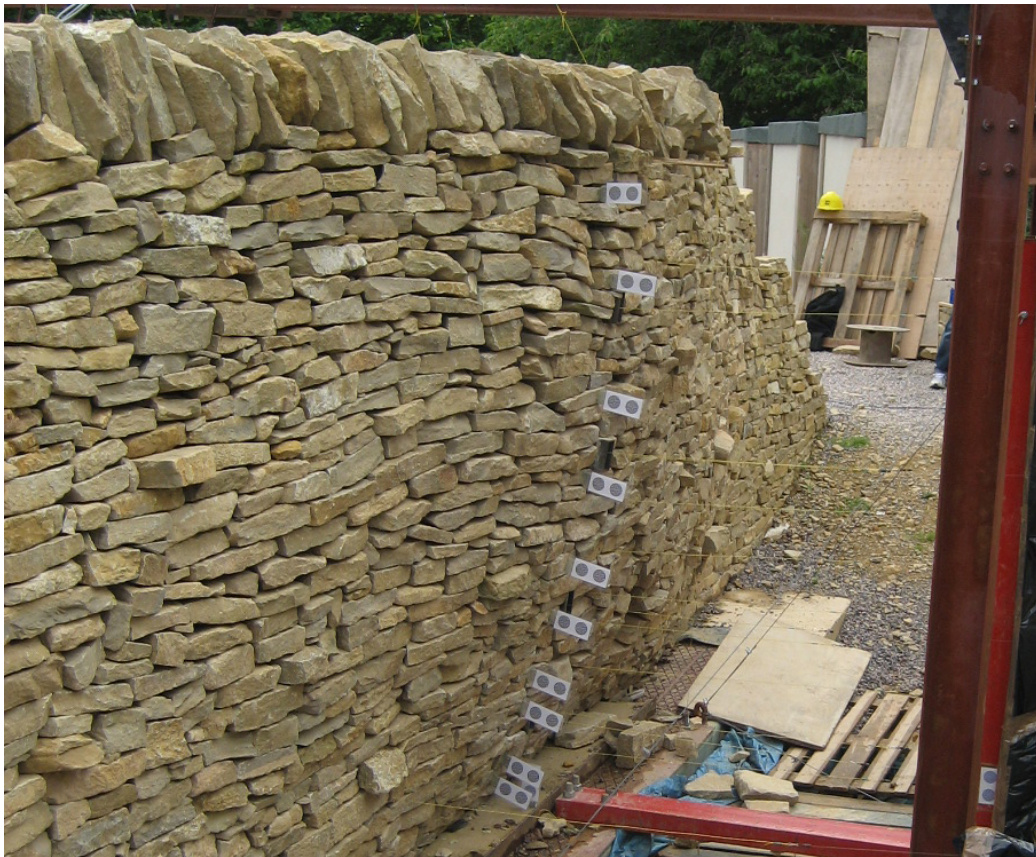
Immediately prior to failure, the bulge protruded over 350mm in front of the toe of the wall, centred at approximately 1.2m above the base. The subsequent

Figure 6-23: Wall 3: Prior to failure

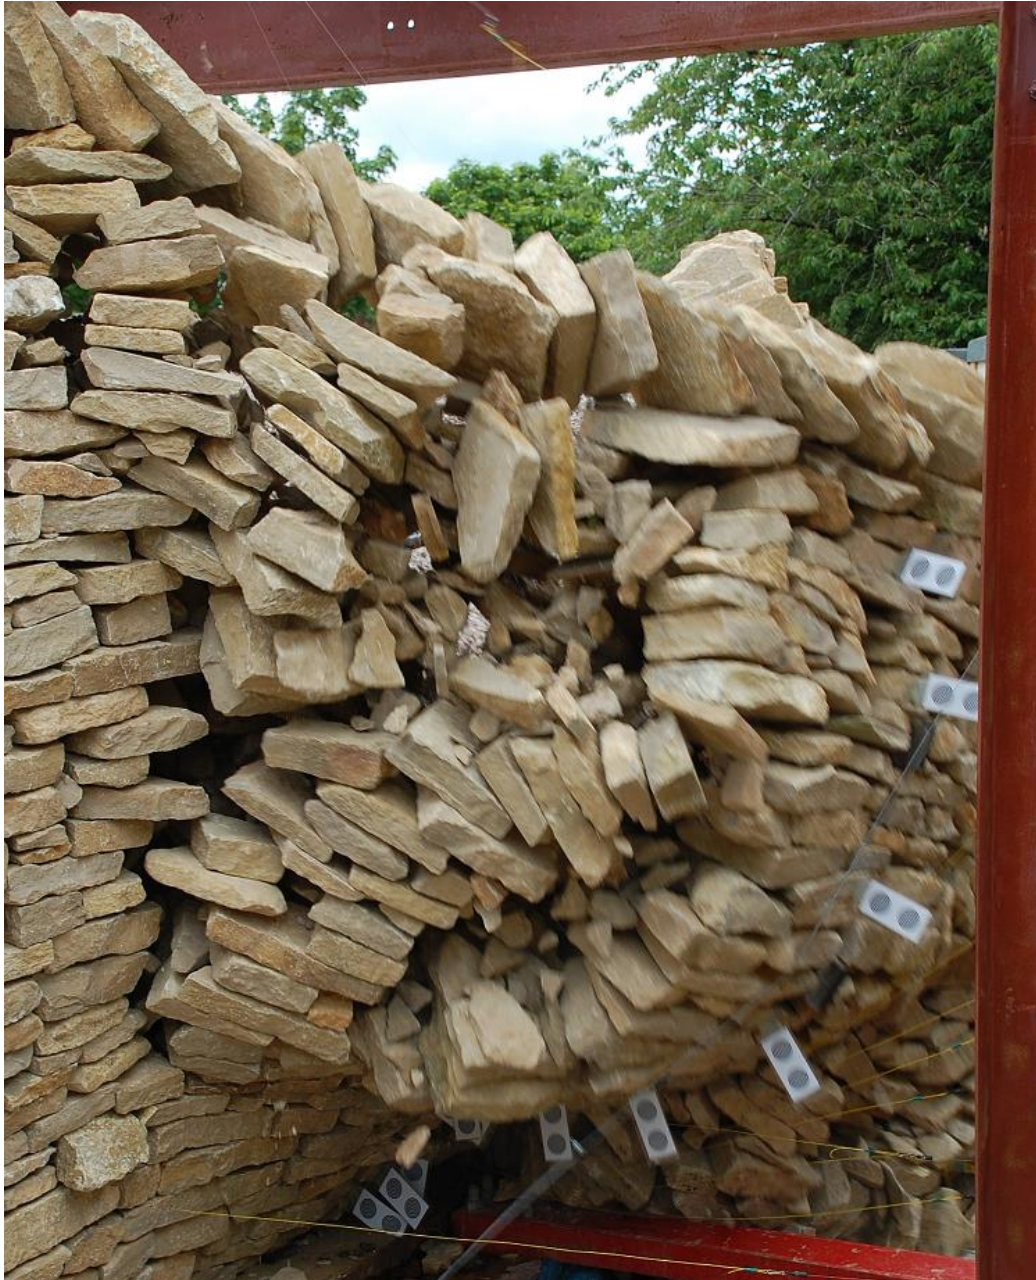
Figure 6-25: Wall 3: Bursting failure

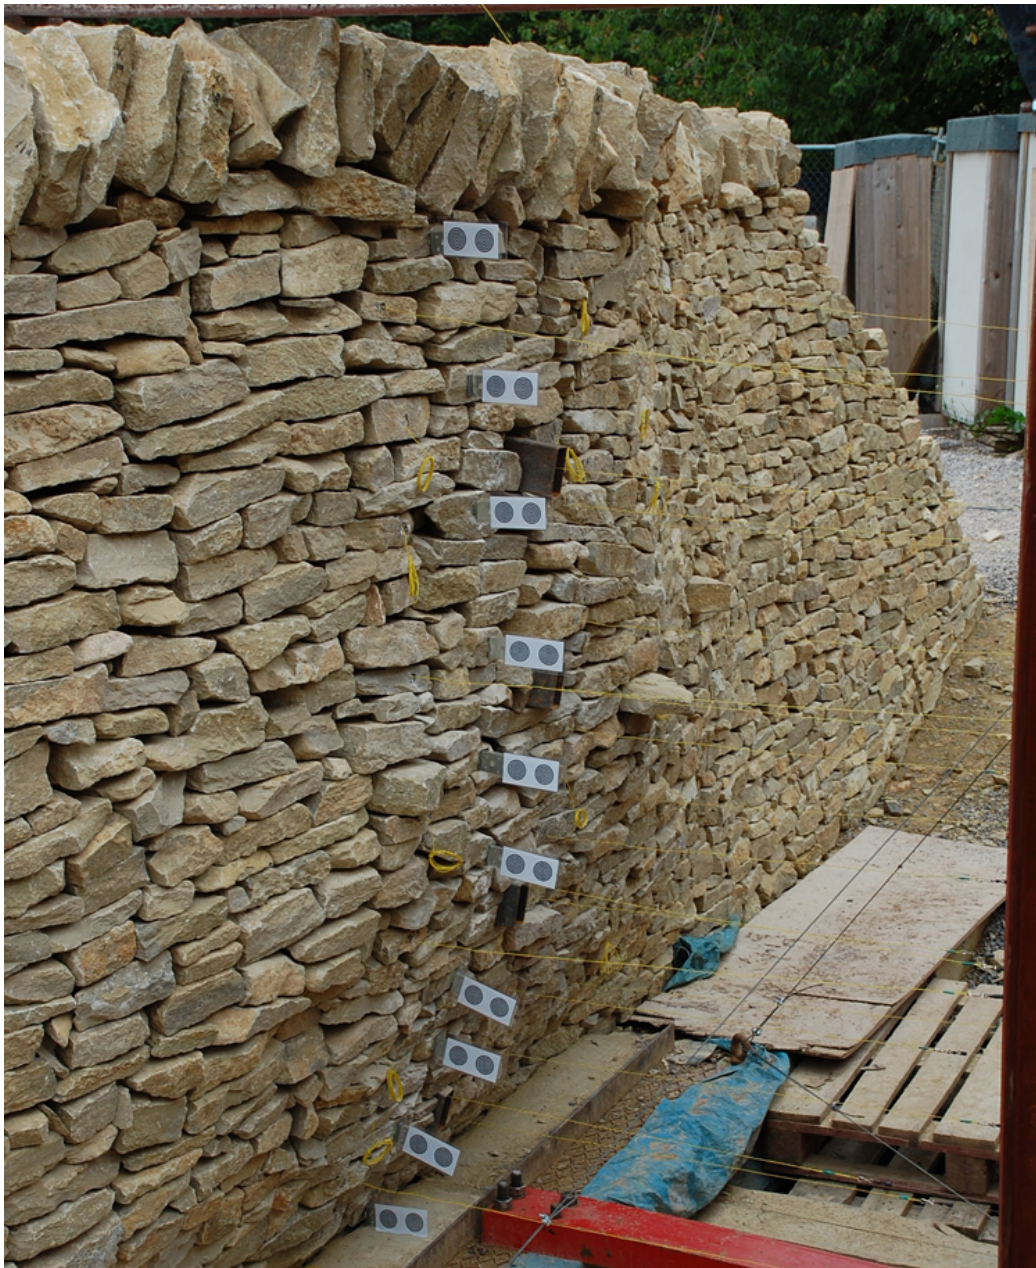
Figure 6-29: Wall 4: Prior to failure

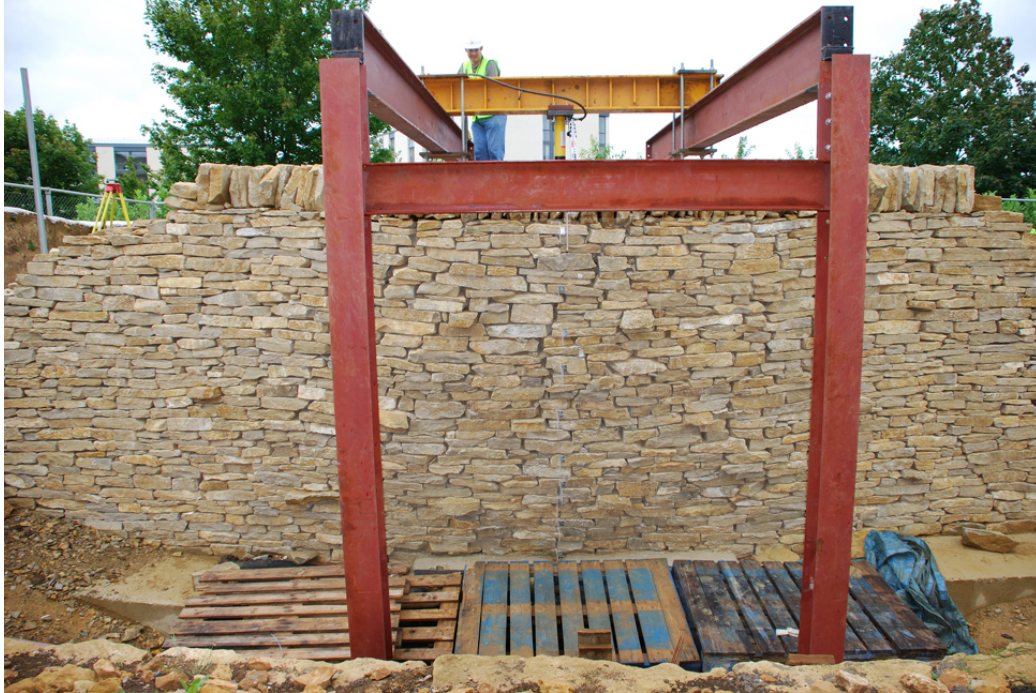
Figure 7-3: Crack propagation of wall 1 prior to failure

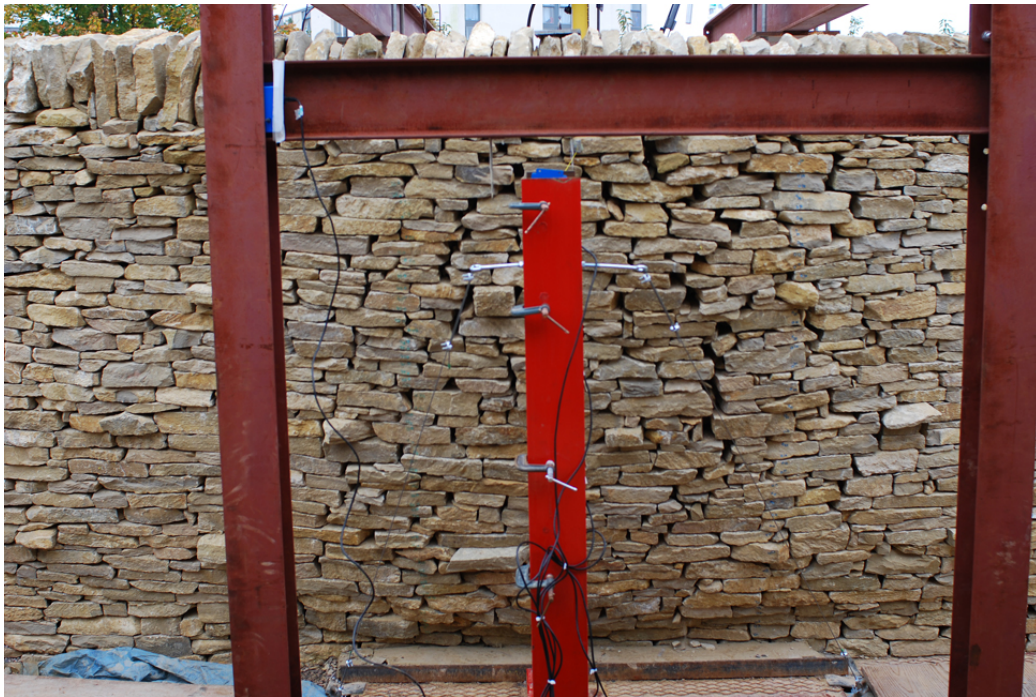
Figure 7-6: Crack propagation of wall 2 prior to failure

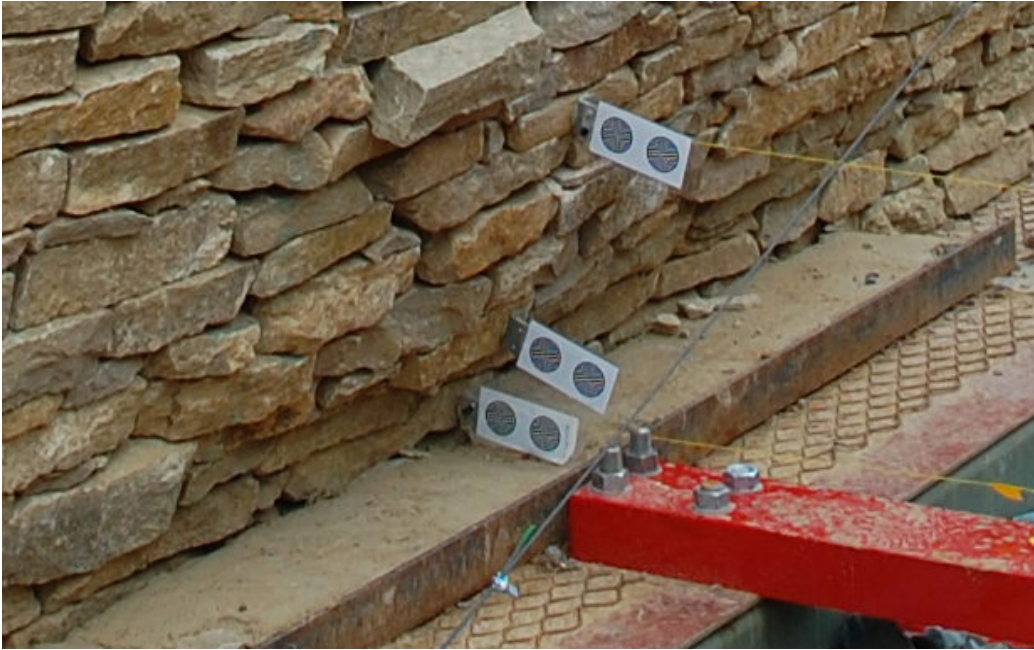
Figure 7-7: Overhanging blocks prior to failure

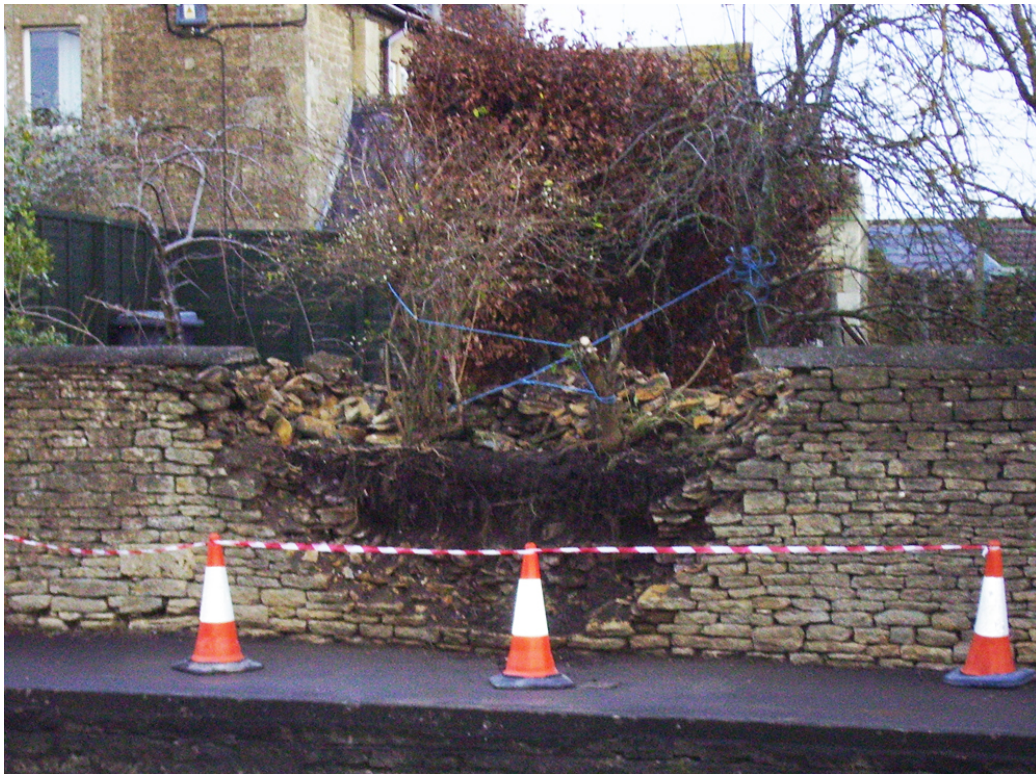
Figure 7-18: Collapsed wall section in Atworth, Wiltshire

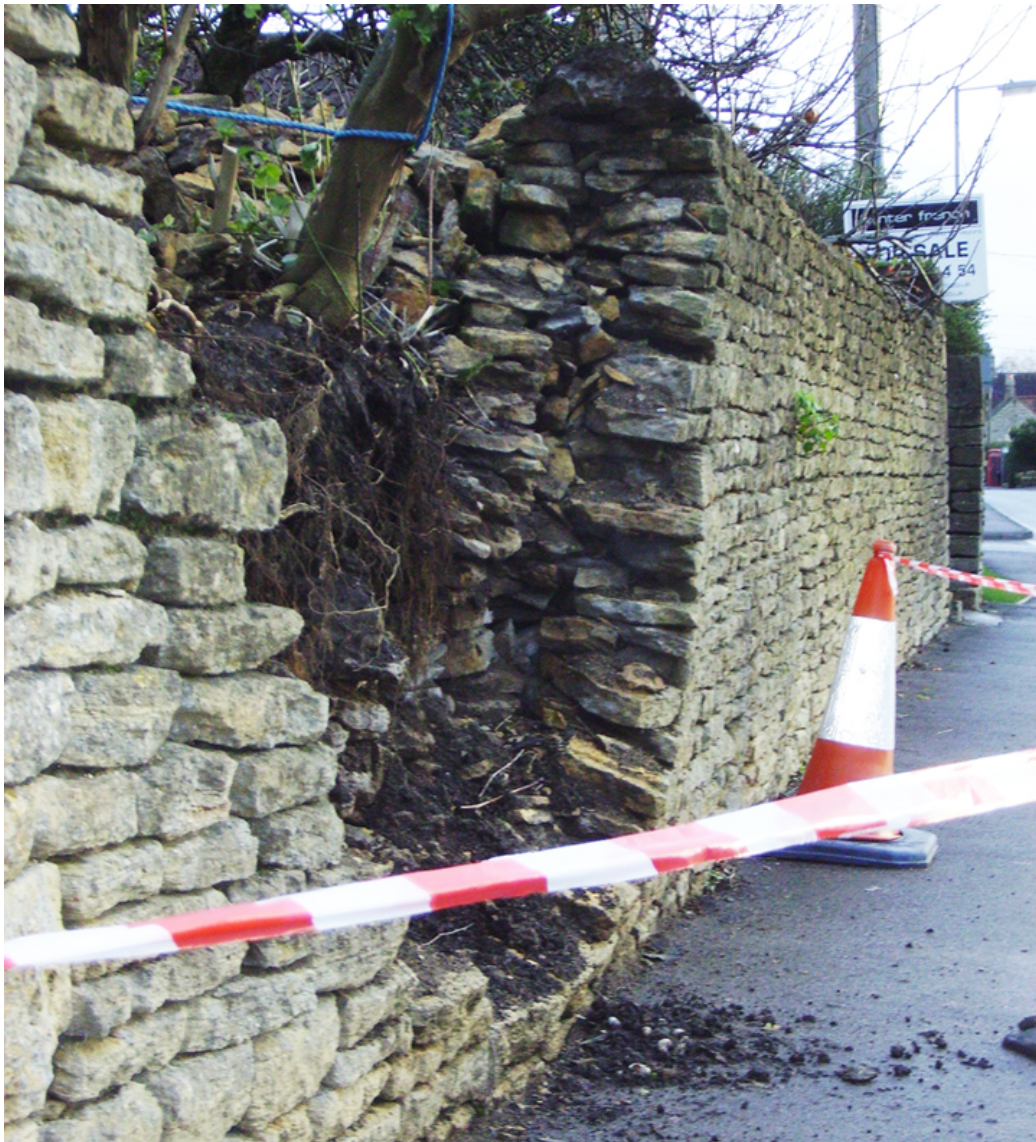
Figure 7-19: Cross section of collapsed wall section in Atworth, Wiltshire

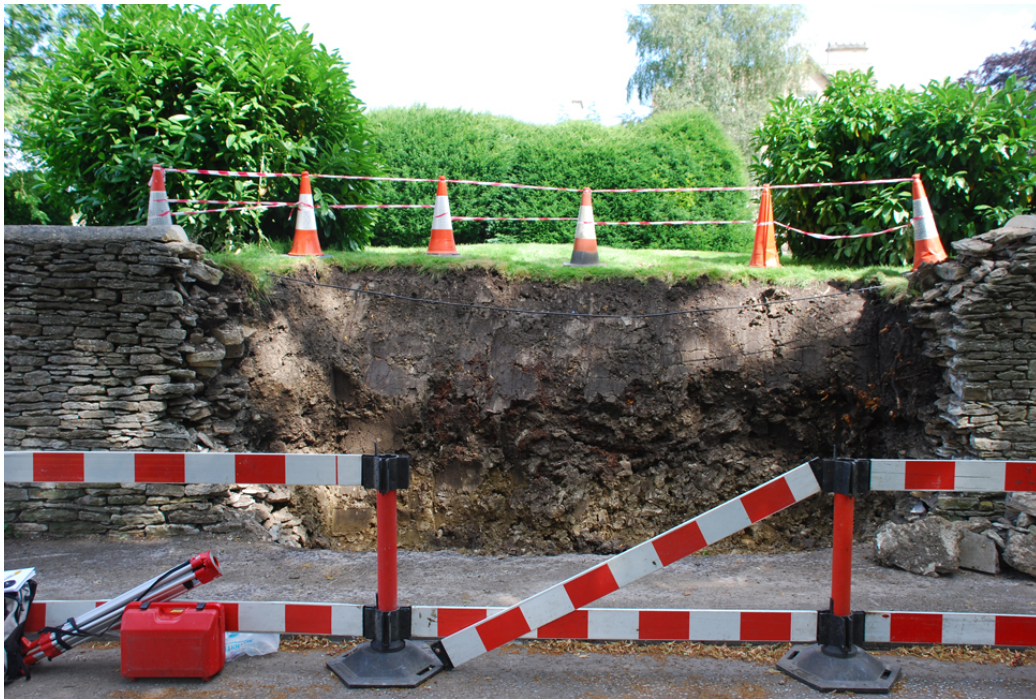
Figure 7-20: Collapsed wall section in Crudwell, Wiltshire

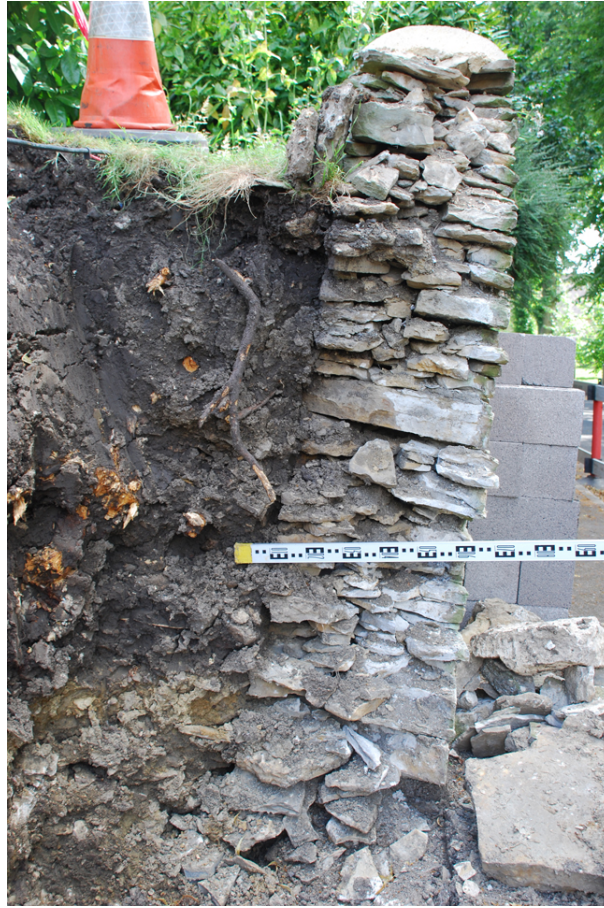
Figure 7-21: Section through collapsed wall section in Crudwell, Wiltshire
